Transport
Canada

TP 6980E

Issue 1/2006

Canadian Aviation Service Difficulty Reports

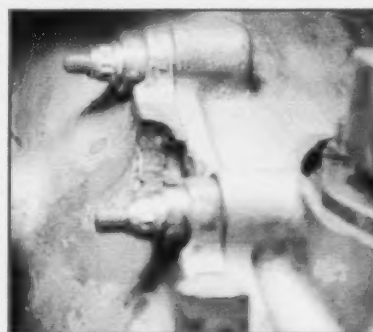
Shortly after aircraft departure, the No.2 AC generator went off-line. The aircraft returned to its point of departure for verification by maintenance personnel. Technicians replaced the generator control unit (GCU), which did not rectify the problem. Further investigation revealed that arcing had occurred between the AC electrical harnesses at the "D" flange location of the engine case.

The arcing caused a noticeable portion of the engine case at the D flange location to be damaged. Short circuits in electrical systems constitute a serious fire hazard and also may cause the destruction of electrical wiring and damage to units of electrical equipment. Visual inspection of proper routing and clearances for electrical wiring harnesses are not always given the same attention as other system installations. This service difficulty is an example of the significance of wiring harness routing and clearance. ✖

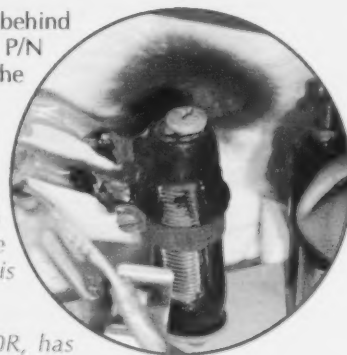
BEECH C90A Resistor Overheated

An overheated resistor, R145, was discovered at the top of the forward bulkhead behind the instrument panel during a routine inspection. The fluorescent light resistor, P/N 2K40D10, was scorched and had slightly burned the insulation located behind the glare shield.

A company fleet-wide campaign produced three (3) similar defects.

Transport Canada (TC) recommends maintainers to carry out a detailed inspection of this area to ensure that adequate clearance between the secured resistor assembly and aircraft insulation is maintained.

The operator noted that resistor, P/N D25K10R, has been superseded by P/N 2K40D10. ✖

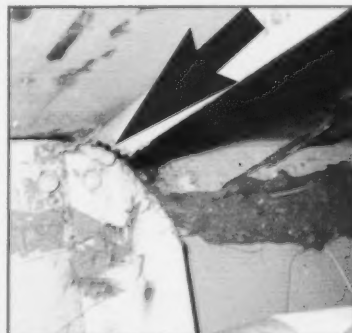
BEECH 200 Bulkhead Cracked

While troubleshooting a pressurization snag on the aircraft undergoing maintenance at an operator's facility, maintenance discovered a 3.5' long crack in a section of the bulkhead lower flange attached at the rear spar at FS 227. The crack was causing a major pressurization leak that could be felt outside of the aft spar box on the exterior of the aircraft. No specific repair instructions are provided in the maintenance manual for this damage.

Upon completion of repairs a pressurization test was completed and the aircraft returned to service.

This defect underlines the importance of careful visual inspection when the aircraft is undergoing maintenance. ✖

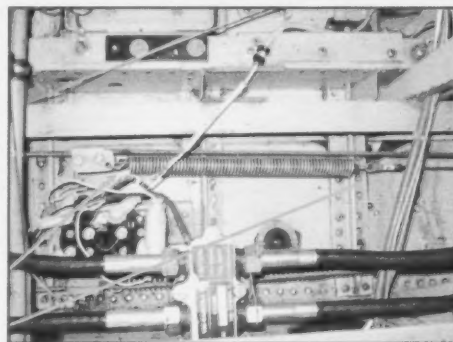
Aileron Spring Fractured

While taxiing the aircraft, the flight crew noticed a full left bias deflection in the aileron system. Maintenance discovered that one of the aileron/rudder interconnect springs had fractured near the end ring that provides connection to the bridle. This defect may have been induced during phase inspection requirements in removal of the springs during tensioning procedures. The tool marks from a set of pliers or other mechanical means during the removal process may have scored the spring, providing areas for stress risers to develop.

The operator issued a supplemental inspection into their process control to avoid future occurrences of this defect. Maintainers should remain vigilant when inspecting this area and judiciously use the correct tool to prevent damage to aircraft hardware. ✕

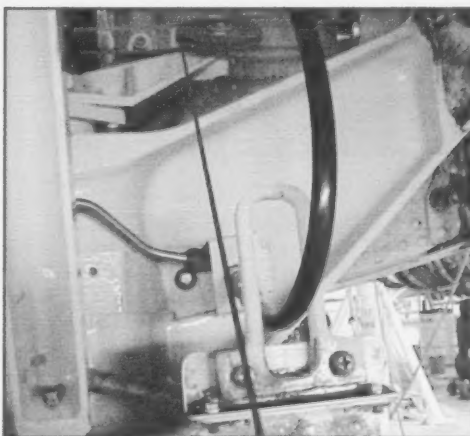
Nose Gear Extension/Retraction Anomalies

The subject aircraft had intermittent history associated with nose gear extension/retraction anomalies. The Pilot reported that the gear lever had to be cycled twice to get the nose gear to extend. A visual inspection was carried out with no obvious faults. The aircraft was ferried back to base with the nose gear selected down.

Upon arrival the transfer cylinder and lock actuator were replaced, along with the nose ski actuator, without successful rectification of the anomaly. The selector valve was then replaced and a test flight conducted, which verified positive operation. Selector valve, P/N 10-61213-1, appeared to have cured the snag. During troubleshooting it also appeared that greasing the points of the nose gear made a difference.

During a recent heavy check this issue was further investigated. Flex line, P/N BACH8A04NM0274T, is a Teflon flex line supplying hydraulic fluid to the nose gear ski actuator. This line was found kinked. It is believed that this finding also contributed to the extension/retraction anomalies by restricting the flow to the nose gear ski actuator.

During troubleshooting the operator noted that nose gear grease fittings were missing and has established an inspection of Main and Nose Landing Gear grease fitting throughout the fleet. It should be noted that some defects can be rectified with part replacement but further investigation and inspection is a prudent approach. Those hidden anomalies can lay dormant and eventually fail causing more down time and possible safety hazards. ✕

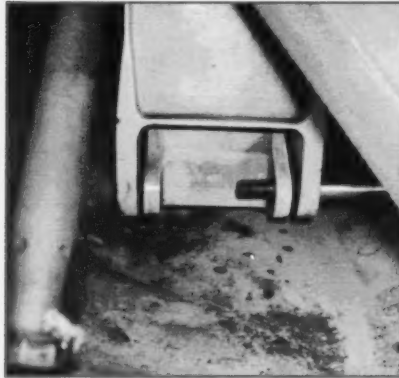
Flap Fairing Attachment Bolt Migration

During ground inspection it was discovered that the AFT attachment bolt of the No. 3 flap fairing had migrated inboard and punctured a hole through the composite fairing. The aircraft was removed from service for repairs.

Upon further investigation, three (3) of the fairing AFT attachment bolts were found without cotter pins installed, two nuts had backed off and the third had separated completely allowing the bolt to migrate. This aircraft had recently had a base visit during which the fairing was removed for access. An investigation is underway with the facility that performed the work.

Human Factors concerns are still prevalent throughout the aviation community. Try to stay out of those elements that cause Human Factors issues to infuse themselves while carrying out your professional duties as an aviation technician. ✖

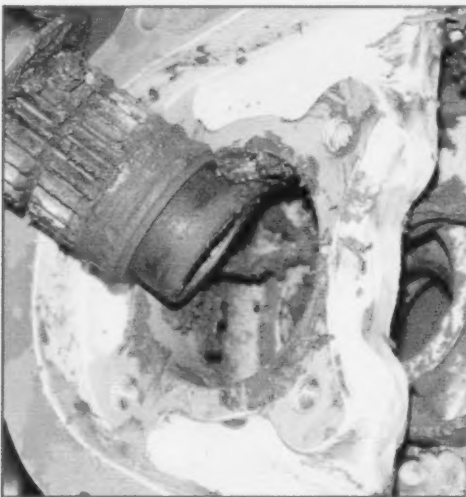
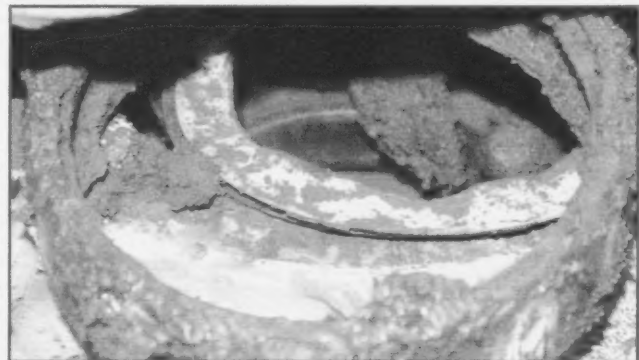
Horizontal Stabilizer Trim Actuator - Severe Corrosion

The horizontal stabilizer actuator assembly, P/N 251T4310-1, was removed from the airplane after maintenance personnel observed rusty grease on the ball screw. Following examination both bearings, P/N 105KS, (Ref: CMM 27-41-01, Item 95) and pinion (Item 100) were found heavily corroded inside the housing assembly, P/N 251T4324-1. The bearings were so corroded that they broke apart upon removal.

The SDR submitter also stated that water ingress is suspected to have occurred (water accumulation) in the housing assembly P/N 251T4324-1. Additionally, the web service difficulty reporting (WSDR) database contains a number of other past and more recent SDRs reporting similar corrosion problems on the horizontal stabilizer actuator.

Transport Canada Civil Aviation (TCCA) reported this SDR to the FAA expressing our concerns about severe corrosion of the stabilizer trim actuator, and the possibility of reduced controllability of the aircraft. The FAA requested that Boeing make a Safety Determination on the effects of severe corrosion and the effect of the stabilizer trim actuator jamming and reduced controllability of the aircraft. ✖

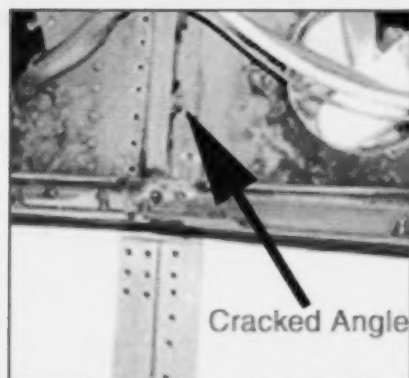
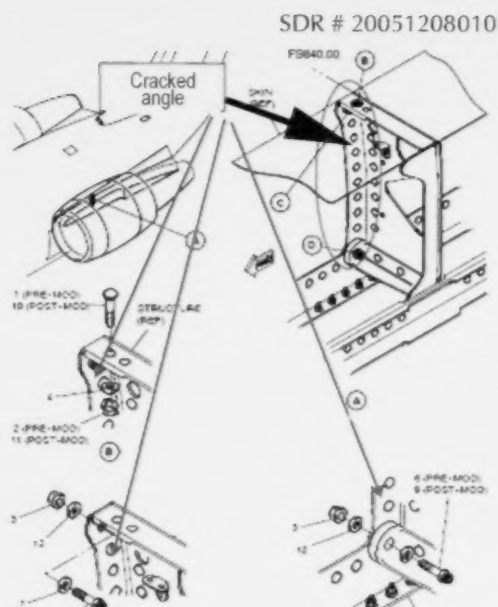
Engine Pylon Formed Angles Cracked

While replacing the engine pylon bolts as per Service Bulletin (SB) 601R-54-005, the AME working in the area noticed that both the left and right side formed angles inside the engine pylon at FS640, Stringer 10, were cracked. Both the left side angle, P/N 601-37003-81, and the right side angle, P/N 601-37003-82, were removed and replaced.

As in this case, an astute technician also found another defect in the immediate area. Good work! ✂

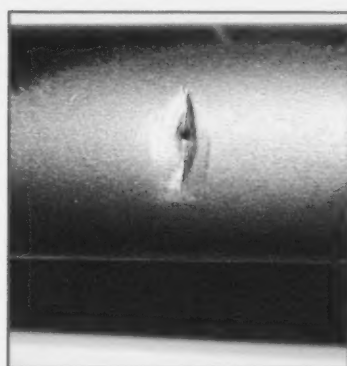
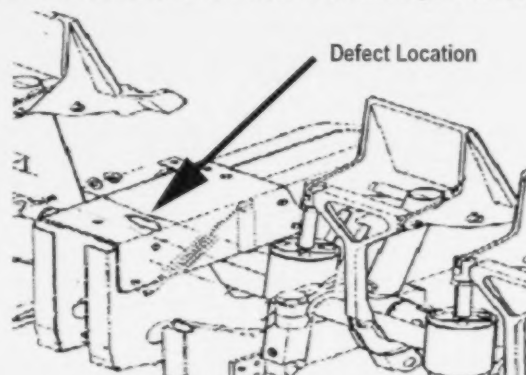
Rear Rudder Bar Worn

During a 100-hour inspection of a Cessna 152, the rear rudder bar was found to have a hole worn through it on the co-pilot side.

The plastic centre console is attached to the rudder pedal covers with screws. If the screws are too long, they will wear into the rudder bar over time. This could eventually cause the rudder bar to fail causing the loss of rudder control.

This was the second identical finding on a similar airplane.

Always ensure that correct parts are installed! ✂

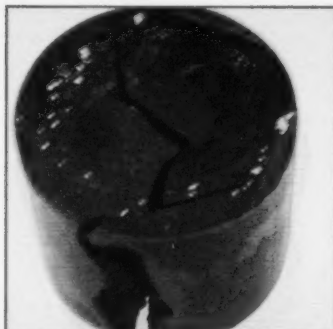
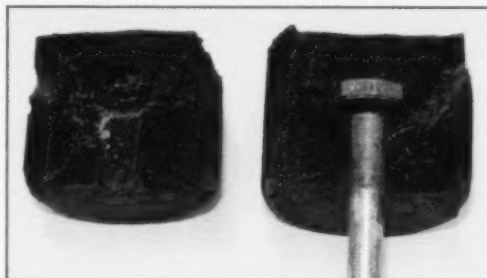
Excessive Elevator Control Travel

An abnormal amount of elevator travel was observed during flight control range of travel checks. Maintenance discovered one upper elevator stop bumper assembly was missing and the other upper elevator stop bumper assembly split. No damage was noted to the surrounding structure.

Canadian Airworthiness Directive CF-2001-08R1 indicated that a DHC-8 aircraft experienced an elevator trim problem in flight, due to a broken or missing elevator stop bumper. Investigation revealed that failure of the elevator stop bumper could lead to an elevator over-travel and damage to the elevator trailing edge if it impacts the top portion of the rudder. The damaged elevator can then jam the spring tab, which could result in reduced controllability of the aircraft. A life limit was therefore introduced for the elevator stop bumpers and revised when in-service experience indicated that the elevator stop bumpers were deteriorating prior to the original life limit.

Bumpers had been replaced 215 cycles earlier, and the elevator stop bumper assemblies were replaced in accordance with the Aircraft Maintenance Manual, AWL TR 2-20 and CF-2001-08.

Stay vigilant during inspection of this area for deteriorating or missing elevator stop bumpers and report any reportable Service Difficulties as per CAR 591. ✖

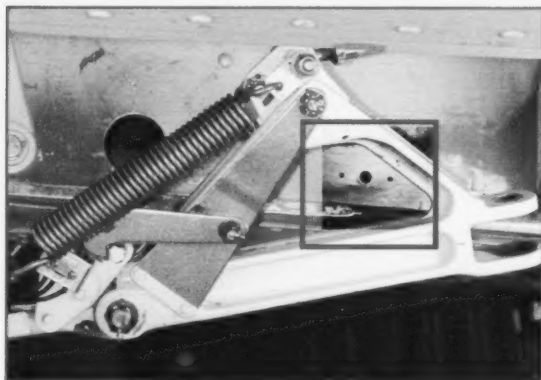
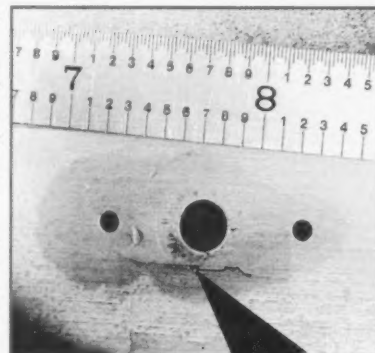
Wing Spar Cracked

During scheduled maintenance, a wing main spar extrusion crack was discovered near the main landing gear sidestay support brackets on the left and right sides. The spar cracks run spanwise in the fillet radius and extend through the full thickness of the spar web. The longest crack is about 1.25" long.

These defects were initially detected through an inspection hole looking at forward side of spar web and later confirmed by removal of sidestay supports and inspection from aft side.

Maintainers should keep this in mind while inspecting this area; the sidestay brackets are the subject of Airworthiness Directive 97-01-01R1. The wing spar is a principal spanwise member in the structure of a wing and is subjected to even greater stresses during flight and landing. Cracks are thus more probable to occur at landing gear attachments on the rear spar. ✖

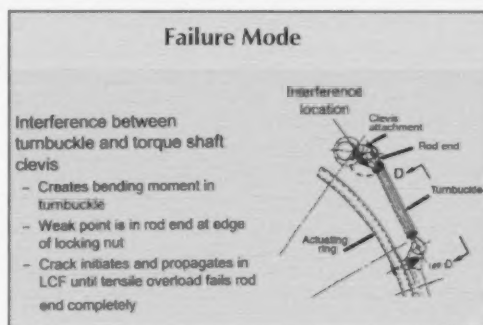
High Pressure Compressor (HPC) Variable Geometric (VG) System Turnbuckles - Fractured

A CAR 573-accepted, European Aviation Safety Agency (EASA) 145 maintenance organization, performing maintenance on Canadian-operated engines has reported failures of three Stage 2 VG turnbuckles, affecting two engines operating in regular revenue service. The subject engines were last inspected by this AMO. The details of the failure were a separation of the VG shaft side turnbuckle rod end, with failure occurring in the threaded portion where it meets the jam nut on the turnbuckle assembly. The failure mode has been confirmed to be low cycle fatigue (LCF), resulting from a side (bending) load induced by interference of the turnbuckle assembly with the torque shaft clevis.

One of the two engines found with the broken turnbuckle condition experienced an in-flight shutdown (IFSD). The IFSD occurred because failure of both turnbuckles did not allow the HPC Stage 2 vanes to track properly.

The other engine was found with only one broken turnbuckle and thus did not result in an operational event. The VG system can work properly for some time on one turnbuckle, however if both turnbuckles fail, an IFSD can occur.

The EASA-145 AMO (SDR submitter) has instituted specific shop procedures pending corrective action by the original equipment manufacturer (OEM). The first procedure is to inspect the Stage 2 VG turnbuckles for correct installation and replace any incorrectly installed VG turnbuckles that failed the inspection to ensure that interference will not occur.

Pending corrective action by the TCH, Transport Canada Civil Aviation (TCCA) recommends that operators inspect, at the first opportunity, the VG turnbuckle rigging, the safety wire methods employed and a non-interference fit between the VG turnbuckle and the torque shaft clevis. ✕

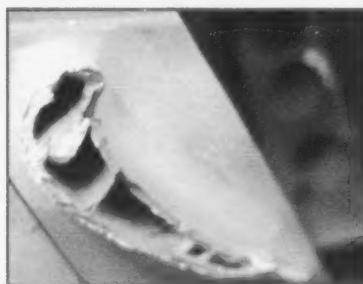
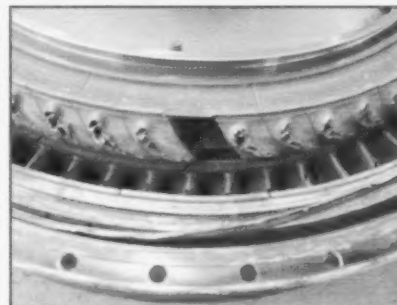
Turbine Over-Temperature

During flight, the crew reported an engine internal turbine temperature (ITT) over-temperature event of 1045 degrees Celsius for 36 seconds. This overheat condition resulted in an uncommanded in-flight shutdown (IFSD).

Engine disassembly at Rolls Royce revealed a number 1 (HPT) high pressure turbine blade failures, at the blade roots.

Although technicians and flight crews take every precaution to prevent over-temperature of the engine, such events do occur. Often the cause of turbine over-temp is a malfunction of engine fuel control or a malfunction in the engine itself.
